Trabuco Canyon Water District

2018 Trabuco Creek Watershed Sanitary Survey

July 2018

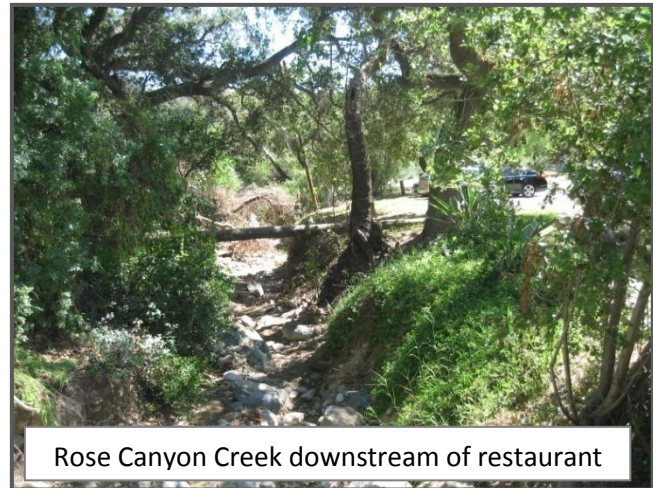
Rose Canyon Creek downstream of restaurant

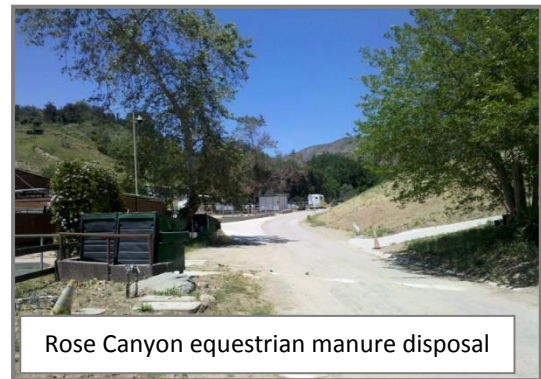
Concentrated animal facilities tend to have stockpiled manure which contains pathogens and nutrients. These uses are of particular concern during heavy and/or intense precipitation events. There are several equestrian operations in the watershed. Many of these facilities offer boarding, training, and access to riding trails. In addition, there are several individual property owners with private equestrian facilities at their homes that may or may not accept boarders.

Equestrian facilities are primarily located along Rose Canyon Road. A small equestrian facility is also located on the north side of Trabuco Creek Road on the former sand and gravel extraction property; an irrigated pasture is on the hill overlooking the facility. According to the ranch manager of one of the facilities, manure is typically disposed of in bins and hauled off-site by the solid waste management company once a week.

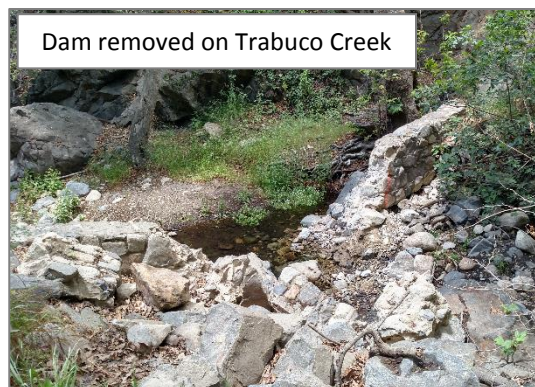
Dam removed on Trabuco Creek

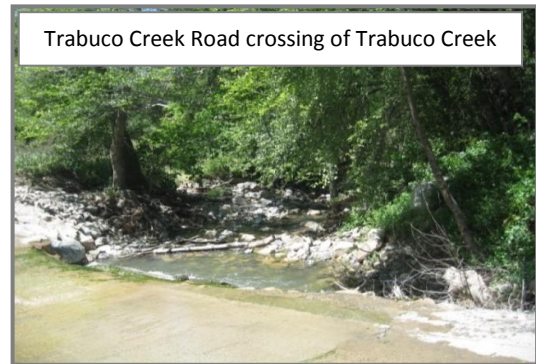
The only activity in the watershed planned by the USFS is associated with Trabuco Creek Road crossings of Trabuco Creek. As shown in embedded WSS photographs, the road is paved wherever it crosses the creek, thus causing an impediment to steelhead swimming upstream. The USFS is working with the Department of Fish and Game in planning to rebuild the creek crossings in the future to aid fish passage by constructing "aquatic passages". This project is associated with the larger project to remove stream barriers along Trabuco Creek and San Juan Creek. The Trabuco Creek dams have been removed since the last WSS; an example is shown in the photograph on page 3-4.
